Re: **Notice of Dangerous Condition**  
**California Government Code §830.**

## Report on Highway 67 Conditions

January 15, 2019

## Appendix. Snapshot and Precise Geolocation of Hazard Areas with Local Map View

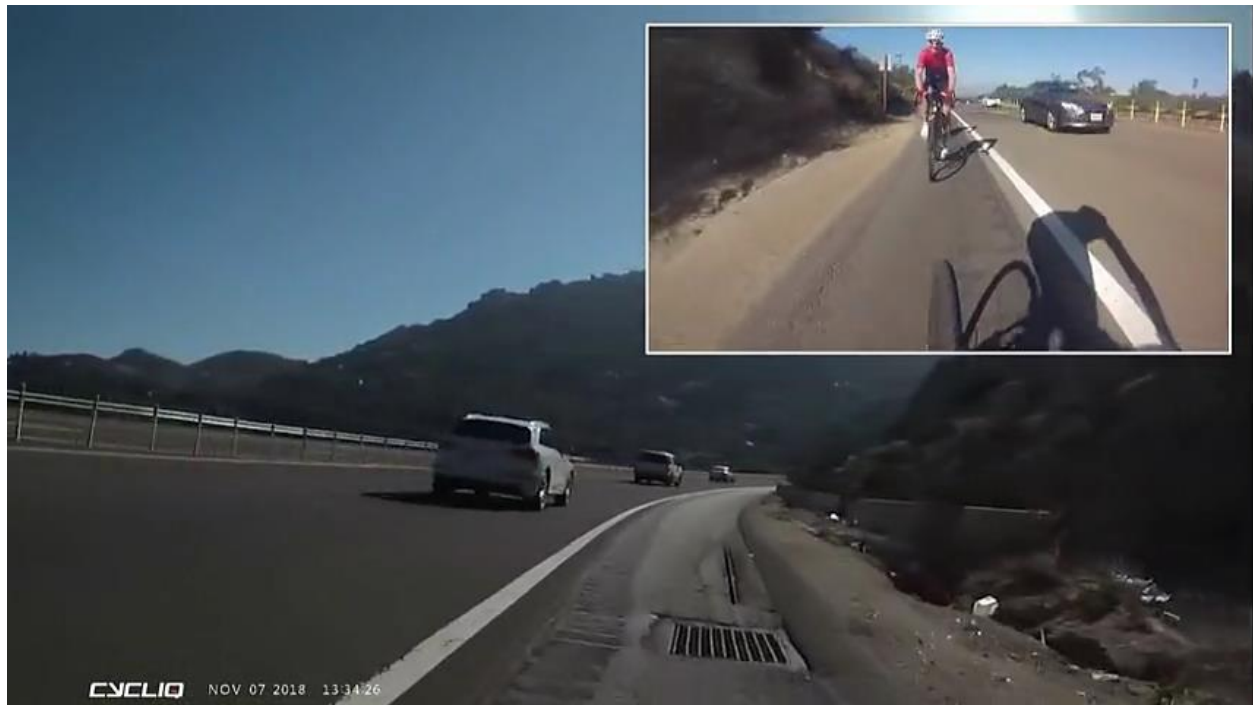
Figure 1. Grate squeeze right of rumble strips southbound, narrow shoulder, just before Ramona Summit.

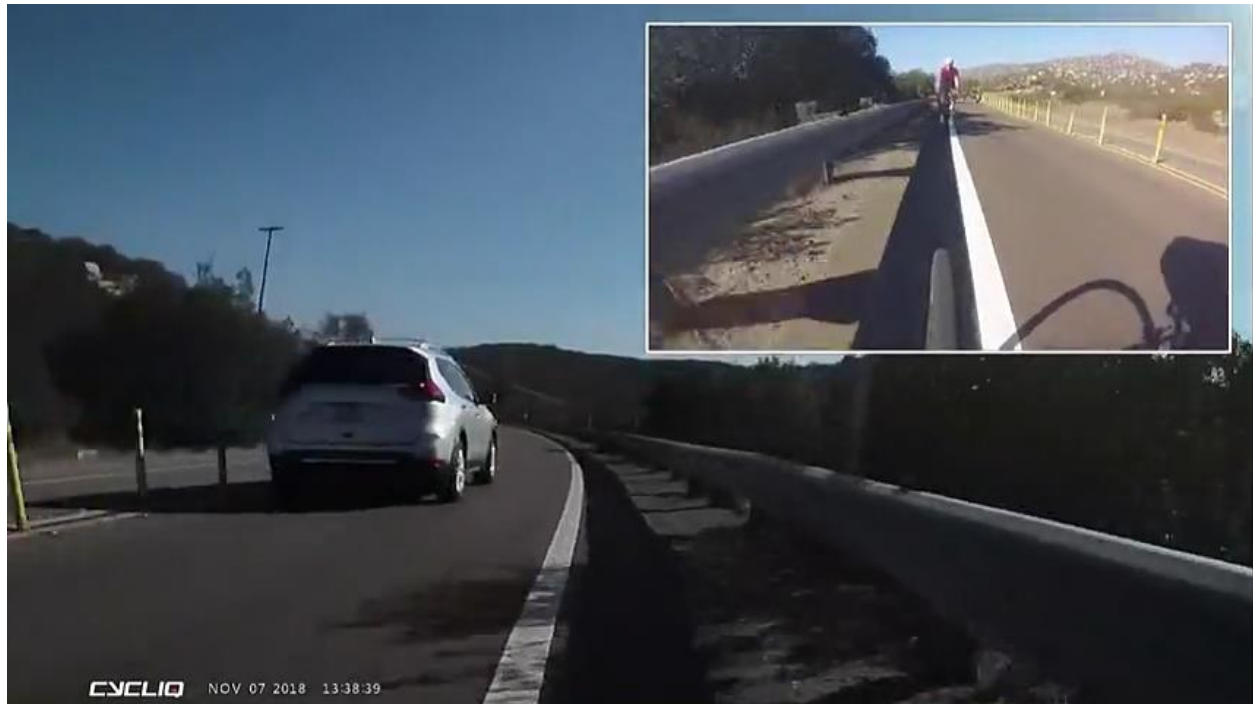
While this document identifies ten hazardous segments, the two worst segments warrant particular discussion. These are roughly between Chapparral Way and Ellie Lane, where there is only one travel lane northbound and southbound (#2 and #8 in Table 1 below). There the cyclist often has *at most* 3 ft. of usable shoulder, rumble stripes in the edge line, and a guardrail on the right. Vehicles traveling at high speed, on the other hand, are trapped on the left by centerline delineators, so that they may wander onto the shoulder and their drivers can no longer move left when safe to do so to give cyclists safe passing distance. Drivers of large vehicles and trucks must often violate the 3 ft bicycle passing law when passing a cyclist who is trying to ride in the shoulder. Although legal for the cyclist in these areas to leave the shoulder and control the full sub-standard width lane (< 14 ft wide), the significant speed differential between vehicular and bicycle traffic makes this both impractical and extremely dangerous. It is impossible to traverse the northern section of SR 67 between Archie Moore Rd and Scripps Poway Pkwy, in either direction, without biking through this extreme danger zone. It seems clear the intent of the shoulder treatments was to assume that cyclists would ride in the shoulder, but it is arguably illegal to make SR 67 effectively unavailable by making that an extremely dangerous option.

Figure 2. Downhill southbound 1 lane, rumble strips, squeeze at guardrail, super narrow shoulder, centerline delineators, EXTREMELY DANGEROUS.

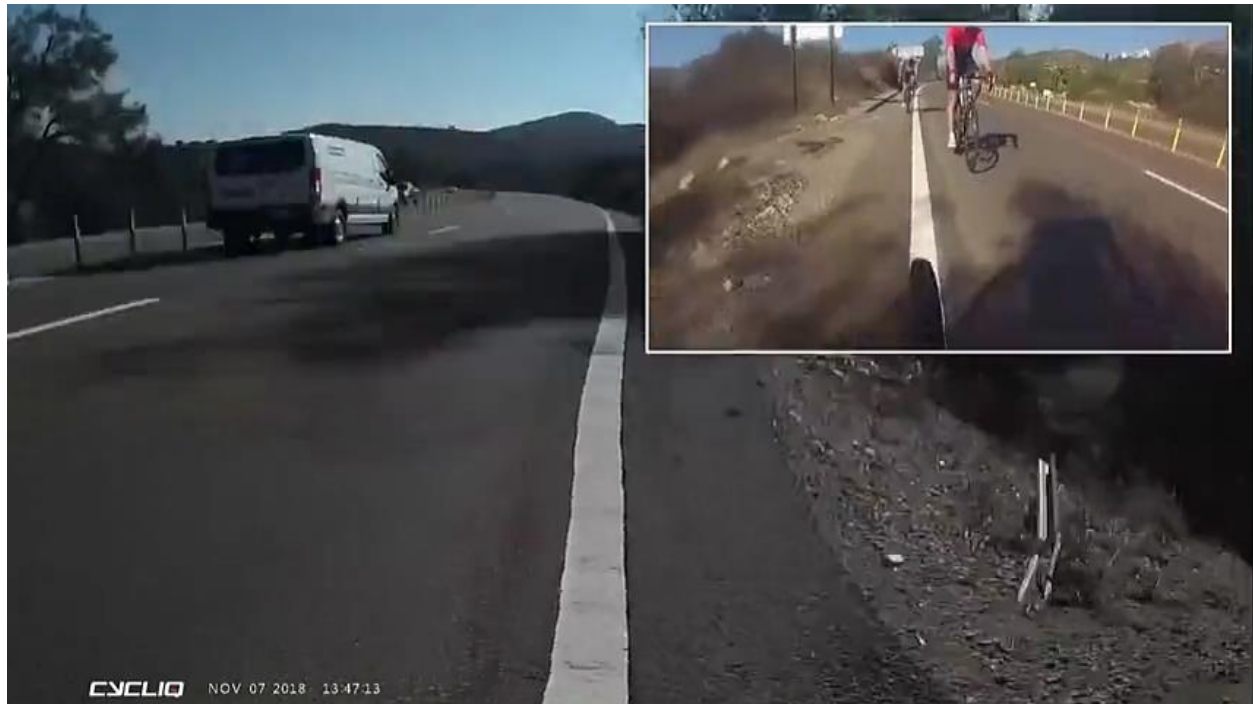
Figure 3. Downhill southbound approaching Scripps Poway Parkway, becomes 2 lanes, rumble strips, at guardrail NO room to ride. MUST control the #2 lane

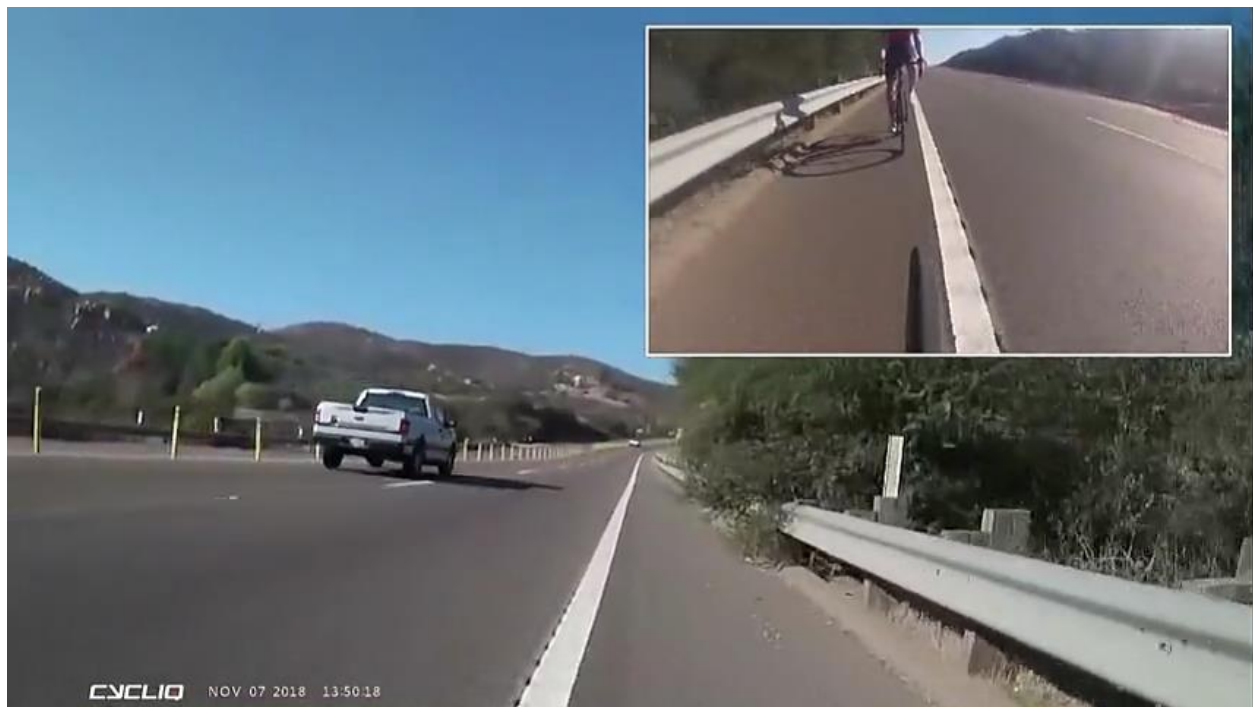
Figure 4. Downhill northbound from Scripps Poway Parkway, dangerous narrow shoulder right of vehicular rumble strips

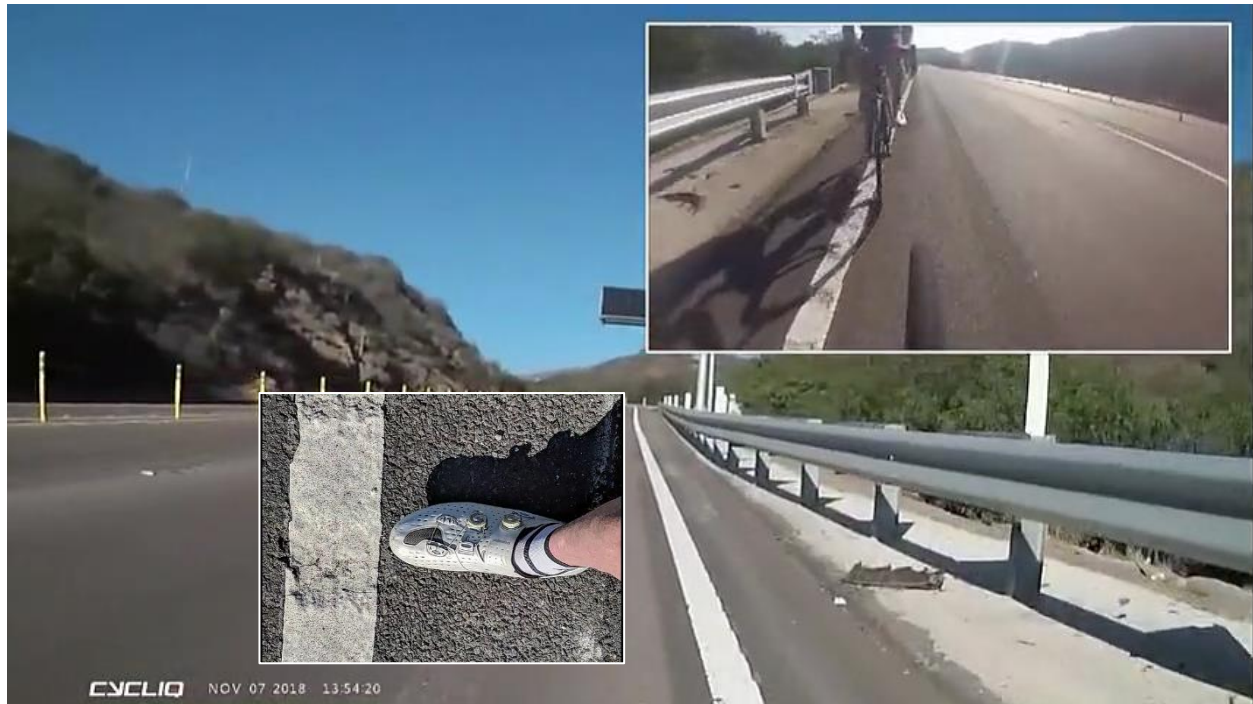
Figure 5. Uphill northbound, half way between Scripps Poway Parkway and Poway Rd, super narrow rumble strip trap at guardrail.

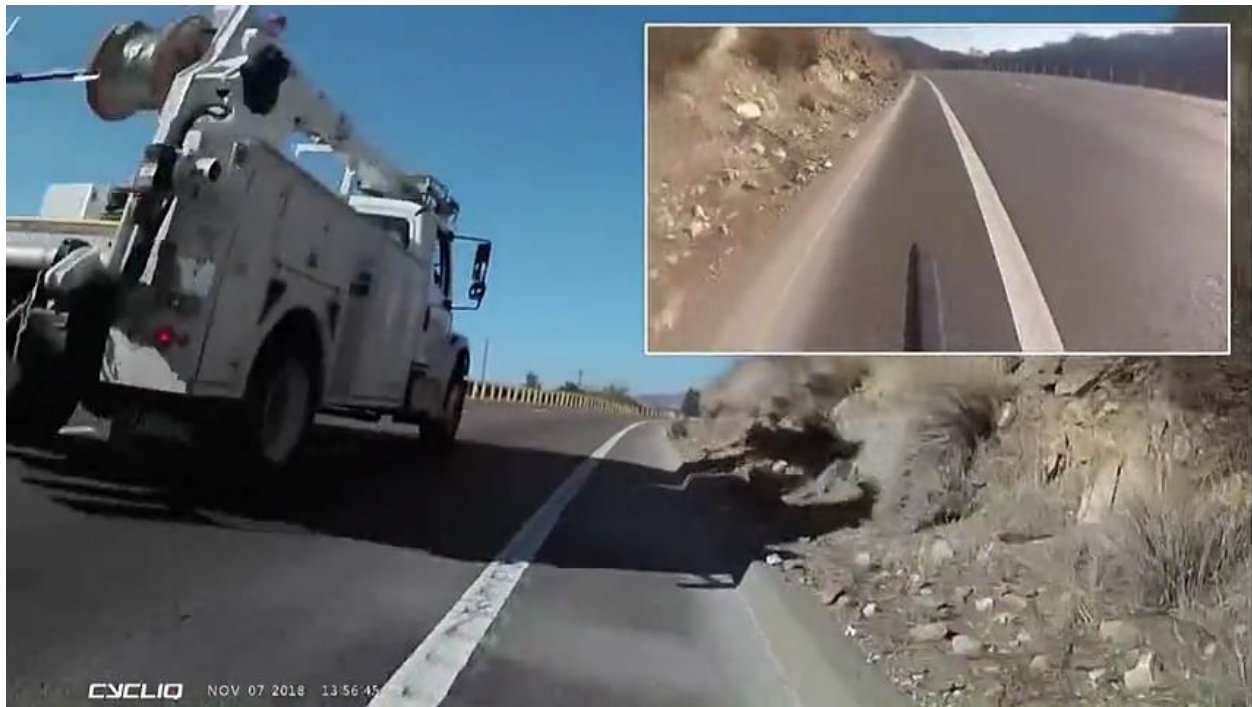
Figure 6. Uphill northbound 2 lanes, rumble strips, before Poway Rd, extremely narrow shoulder.

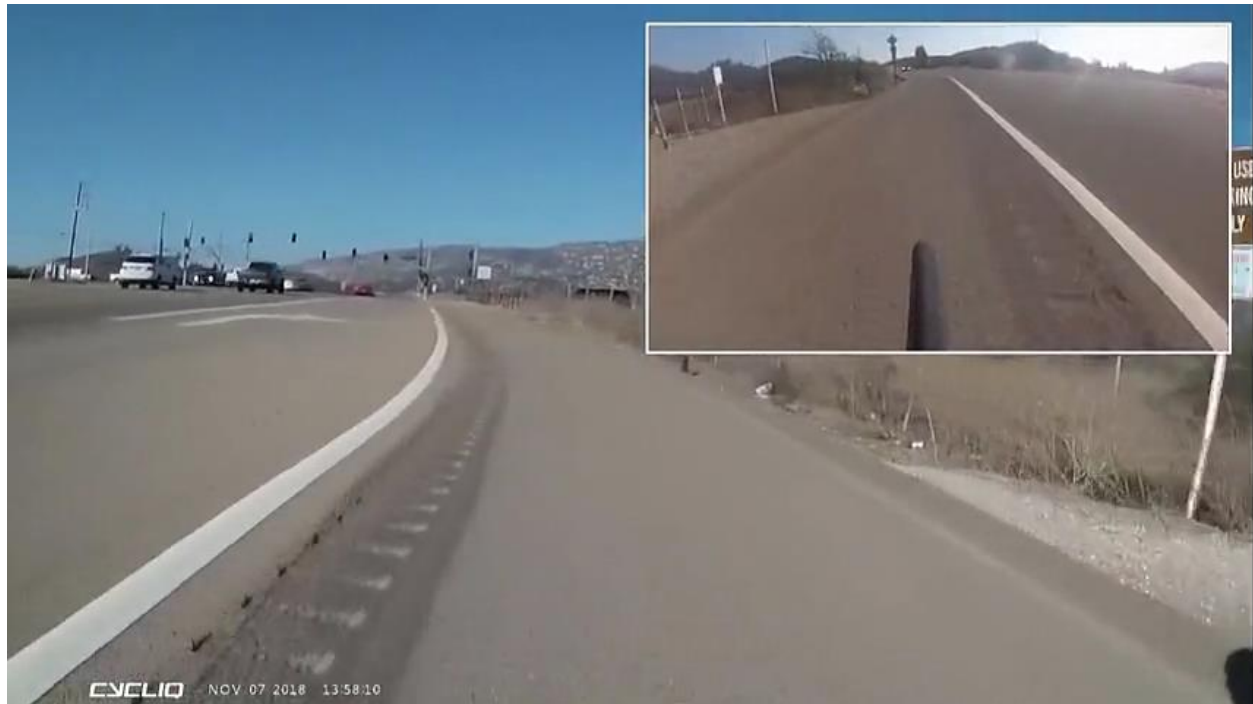
Figure 7. At Poway Rd northbound, through cyclists trapped by rumble strips right of right turn lane to trailhead parking

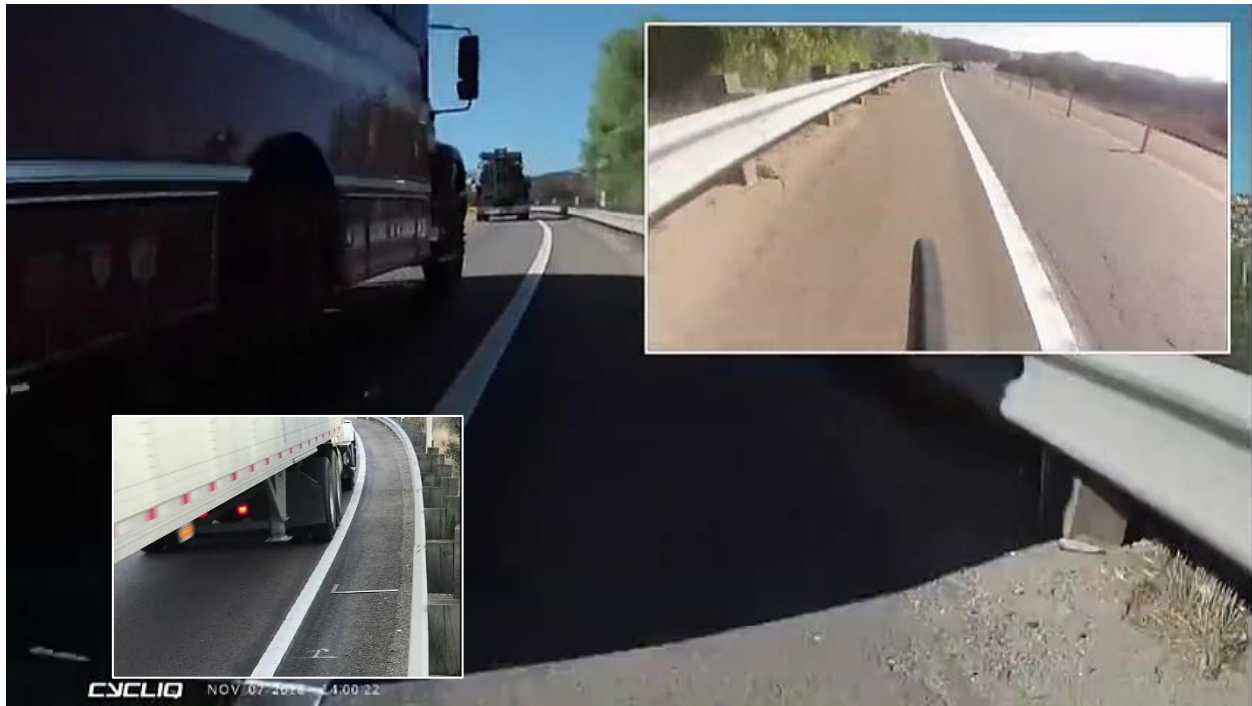
Figure 8. Uphill northbound, 1 lane, rumble strips, center delineators, narrow shoulders, EXTREMELY DANGEROUS.

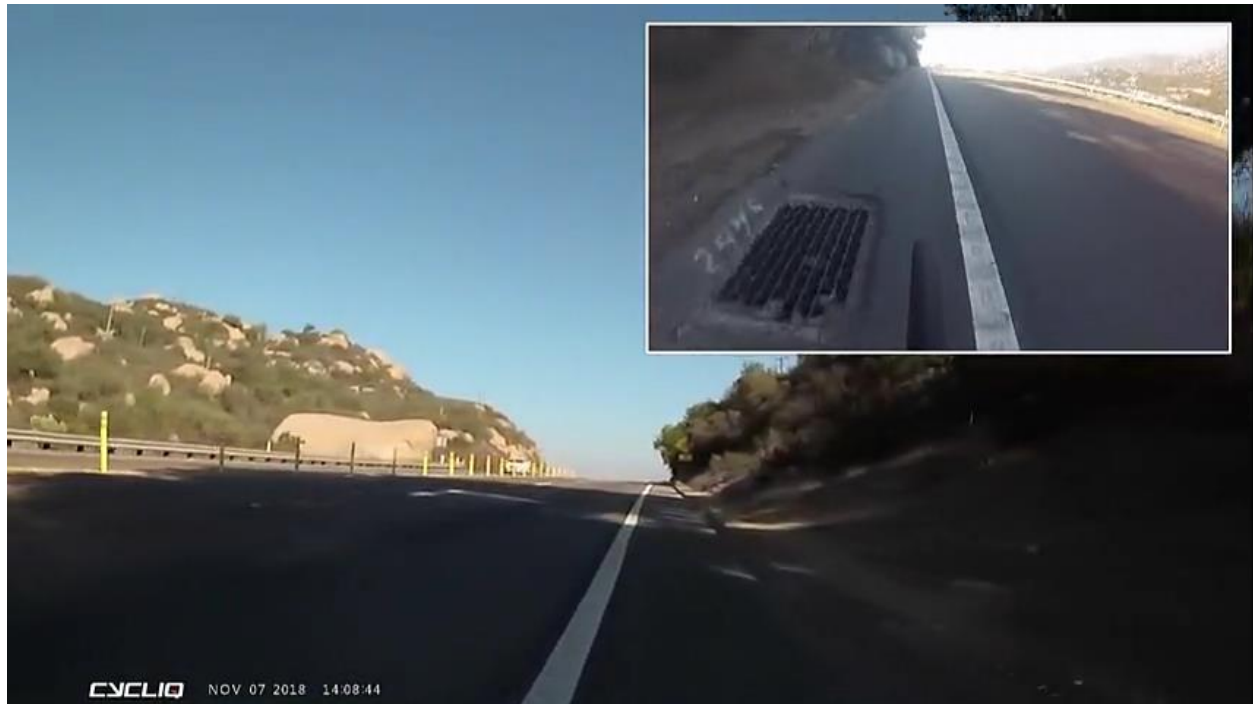
Figure 9. Approaching Ramona Summit northbound, 2 lanes, rumble strips, narrow shoulder with drains and debris.

8	More frequent maintenance to keep area right of rumble strips free of debris and glass.

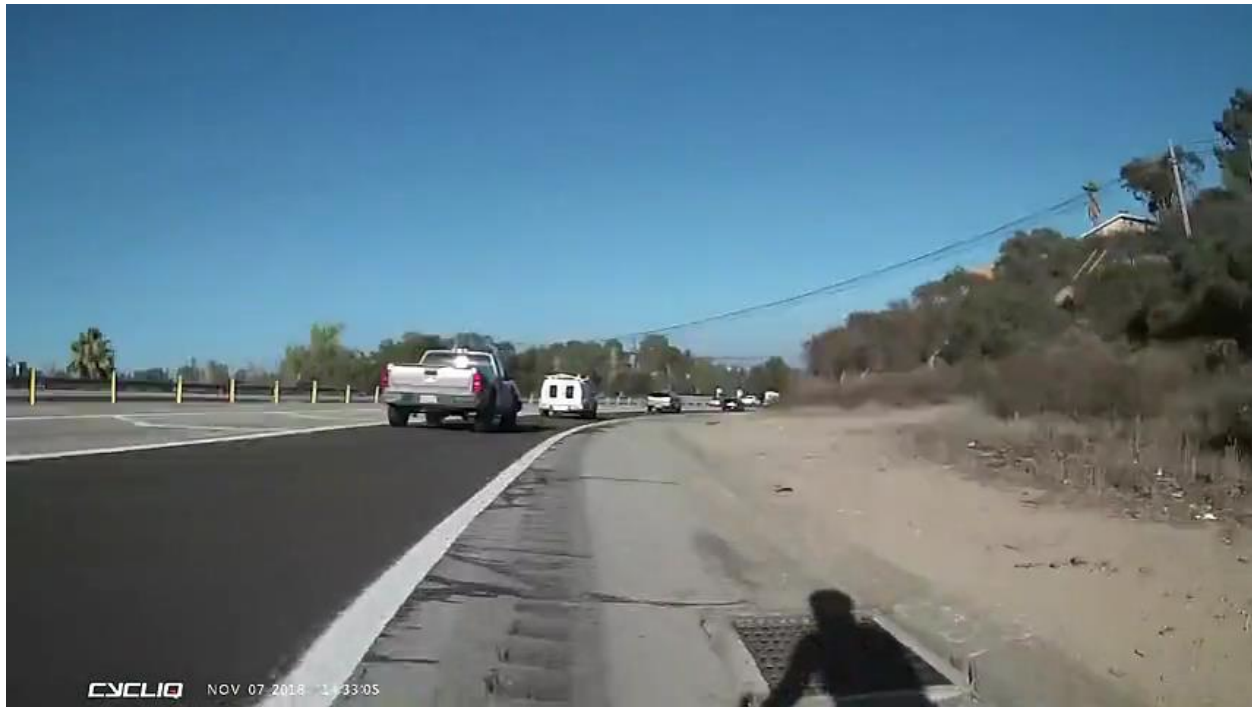
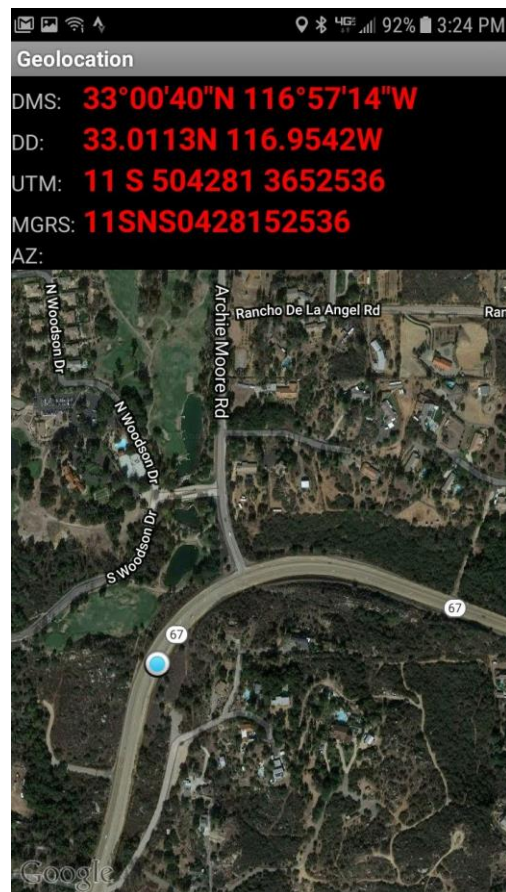
Figure 10. Approaching Archie Moore northbound, rumble strips trap left turning cyclists.
